Step 1 Check the Records

Step 2 General Appearance

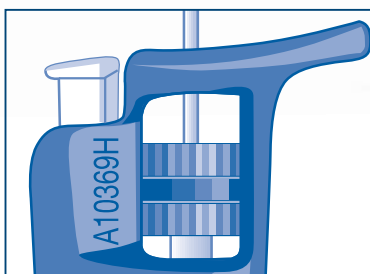
Before 1984		
<u>G</u>	<u>80</u>	<u>12345</u>
Month	Year	Production number

Example of a serial number A 10369 H		
From January 1984		
<u>A</u>	<u>10369</u>	<u>H</u>
Year	Production number	Month

Letter	Year	Letter	Month
A	1984	A	January
B	1985	B	February
C	1986	C	March
D	1987	D	April
E	1988	E	May
G	1989	G	June
H	1990	H	July
J	1991	J	August
K	1992	K	September
L	1993	L	October
M	1994	M	November
N	1995	N	December
P	1996		
Q	1997		
R	1998		
S	1999		
T	2000		
U	2001		
W	2002		
X	2003		
Y	2004		
Z	2005
